I.I.S.
Illinois Inspection Service
Specializing in EIFS Inspections
Phone (847) 746-3963 Fax (847) 746-3966

Barrington, IL

Weather: sunny / 75 degrees
Last Rain: 3 days
Approx. age of property: 14 yrs.
Product: Dryvit

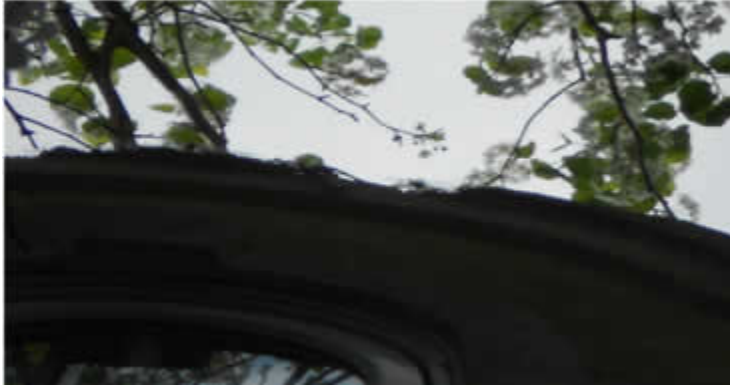
The EIFS system has some damage to the parapet cap on the front upper right corner and at the garage. There are also woodpecker holes in the chimney and right side.. (See EIMA detail 1, Dryvit detail OS 0.0.01, and attached photos)

Parapet cap damaged on right upper corner

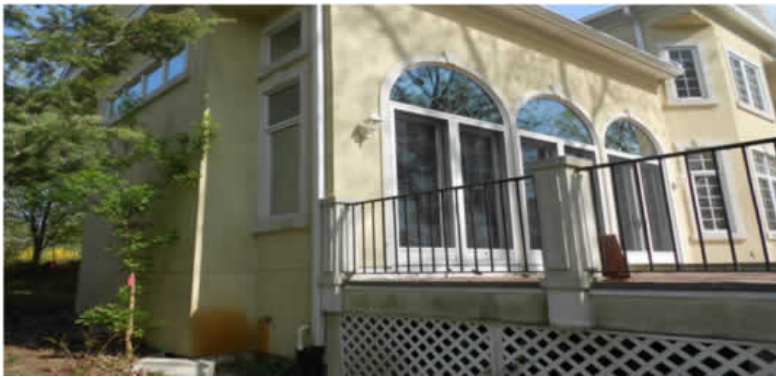
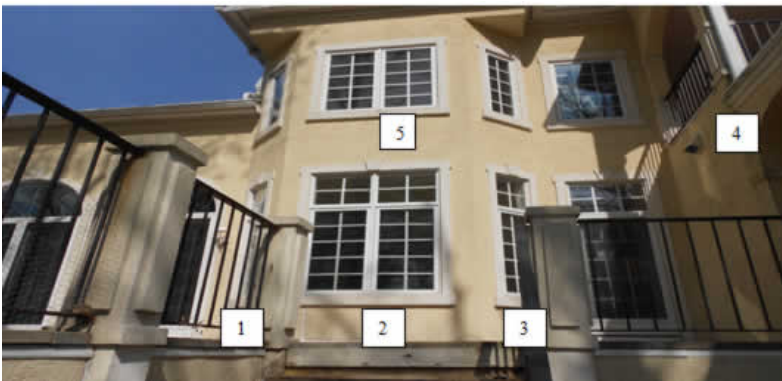
The moisture readings behind the EIFS system appeared to be a high in many areas. 0-19% moisture is acceptable, 20-30% if recaulked/reflashed should dry out over time, over 31% should be removed and investigated further. All soft substrate areas should be removed and replaced. (See attached photos)

- 1) 41% moisture reading
- 2) 36% moisture
- 3) 15% moisture
- 4) 36% moisture with soft substrate
- 5) 23% moisture

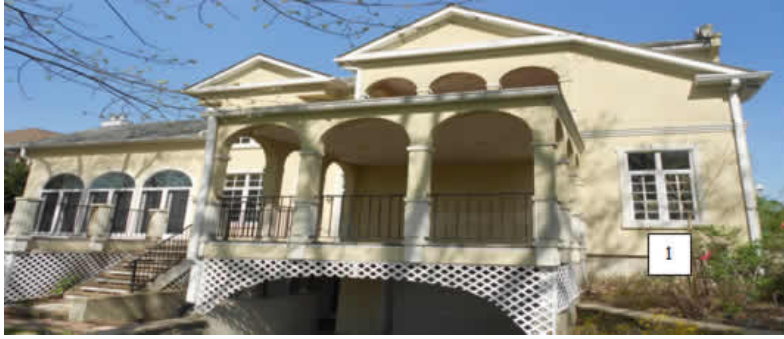
1) 44% moisture reading

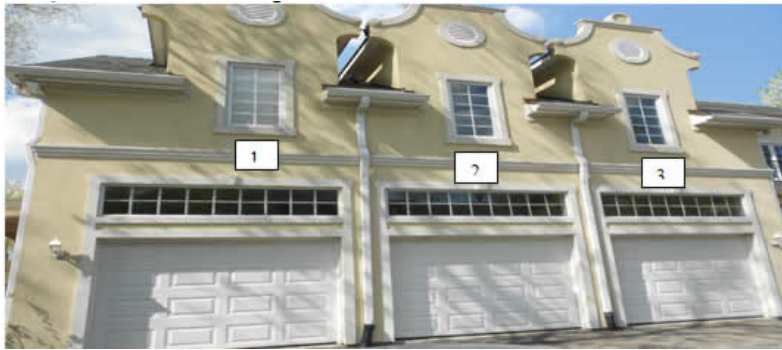
1) over 50% moisture with soft substrate

2) 31% moisture

3) 32% moisture

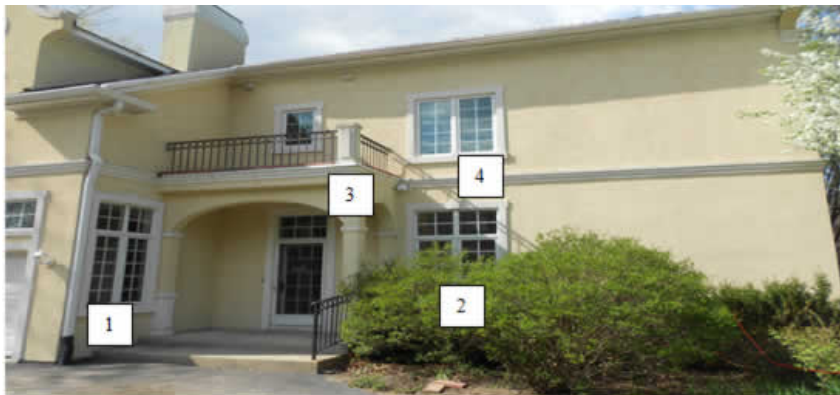
1) 44% moisture reading

2) Over 50% moisture with soft substrate

3) Over 50% moisture with soft sub.

4) 26%

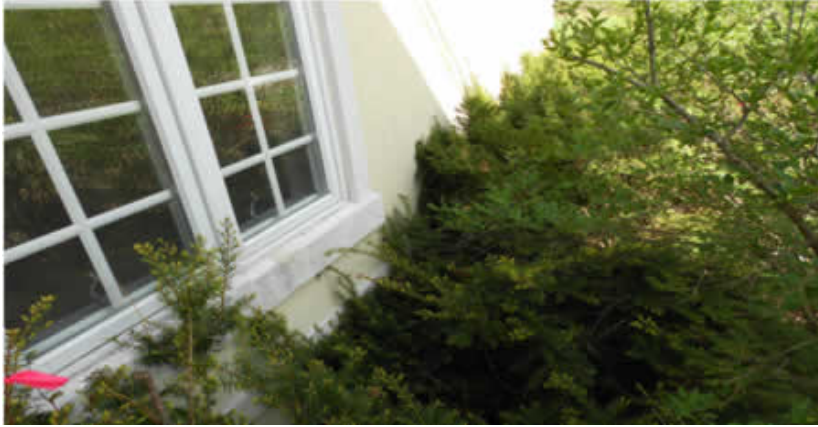
Bushes should be cut back away from the EIFS system (typical)

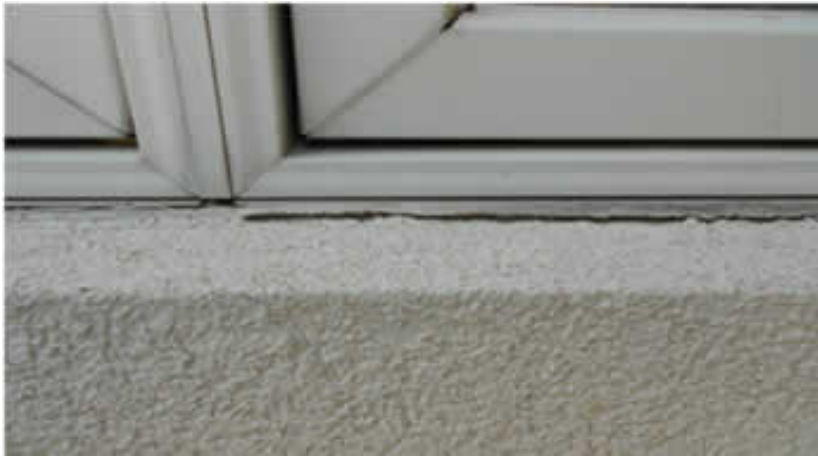
The caulking is failing in many areas. Anywhere the EIFS system meets a dissimilar material should be checked and recaulked. (See EIMA detail 4, attached photos, and EIMA and Dryvit Guidelines for the Inspection of EIFS Clad Houses)

Caulk failing (typical)

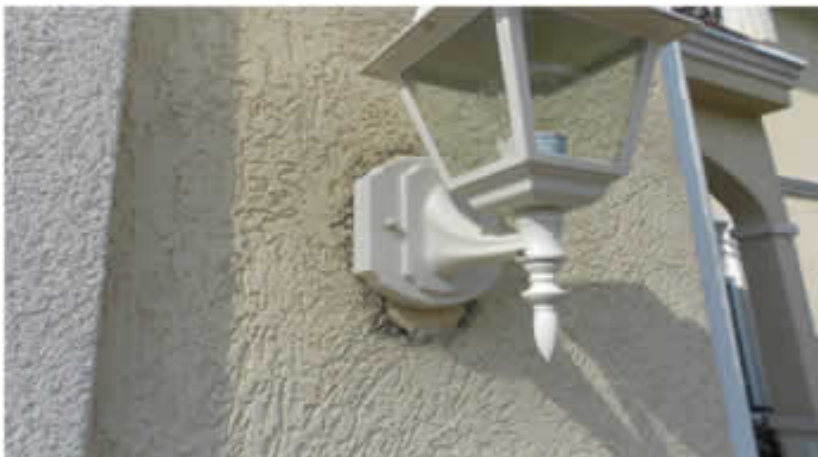
The attachments to the EIFS system have inadequate caulking. These areas are around the light fixtures. (See attached photos, EIMA detail 8, Dryvit detail OS 0.0.28, and also reference EIMA and Dryvit Guidelines for Inspection of EIFS Clad Houses)

Light fixtures need to be caulked (typical)
