**I.I.S.**  
**Illinois Inspection Service**  
Specializing in EIFS Inspections  
Phone (847) 746-3963 Fax (847) 746-3966

Weather: sunny / 70 degrees  
Last Rain: 3 days  
Approx. age of property: 13 yrs.  
Product: Dryvit

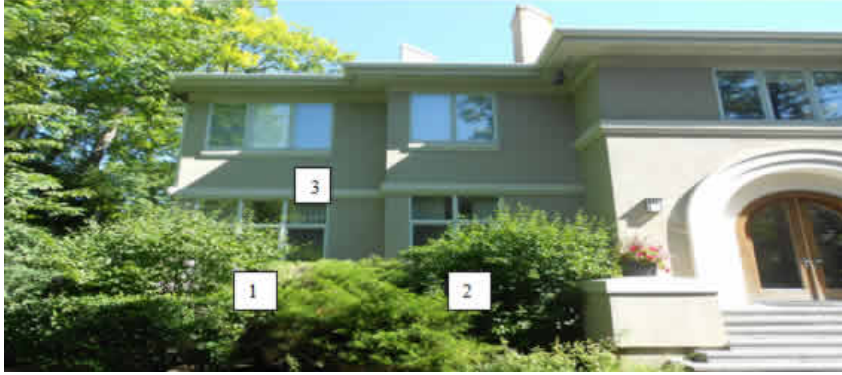
- 1) 22% moisture reading
- 2) 17% moisture
- 3) 15% moisture

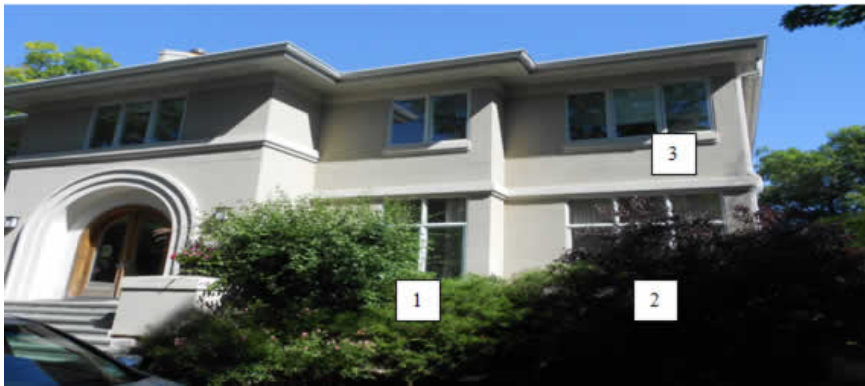
- 1) 24% moisture reading
- 2) 26% moisture
- 3) 17% moisture

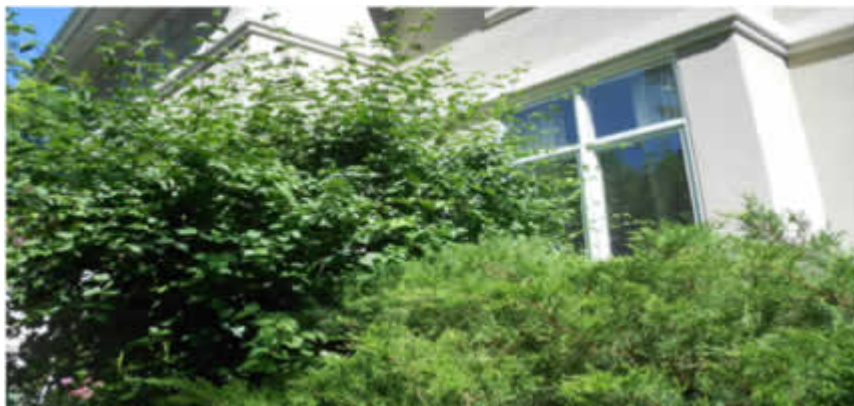
The landscaping has been installed as per the manufacturer's details But the bushes should be cut back away from the EIFS. (See EIMA detail 3, Dryvit detail OS 0.0.03, and attached photos, and also reference EIMA and Dryvit Guidelines for the Inspection of EIFS Clad Houses)

Bushes should be cut back from the EIFS system. (typical)

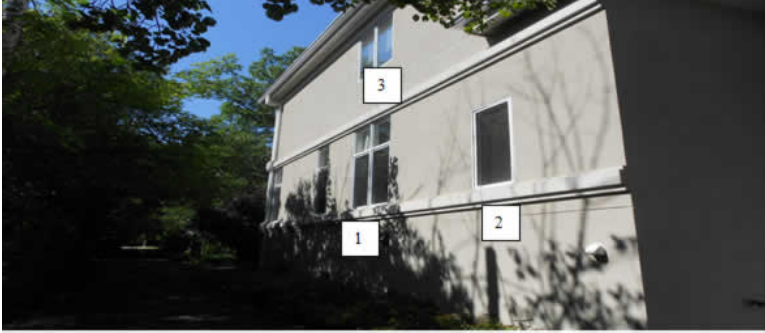
- 1) 27% moisture reading
- 2) 26% moisture
- 3) 12% moisture

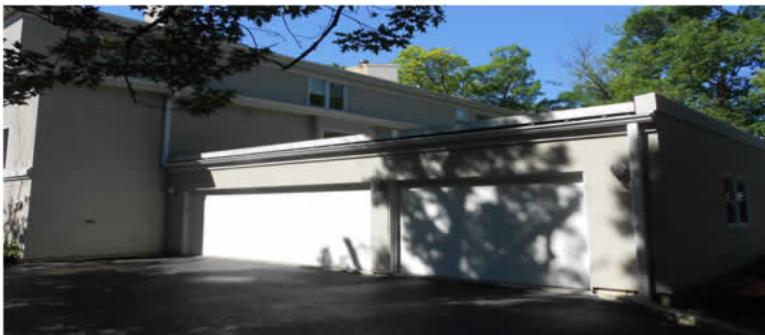
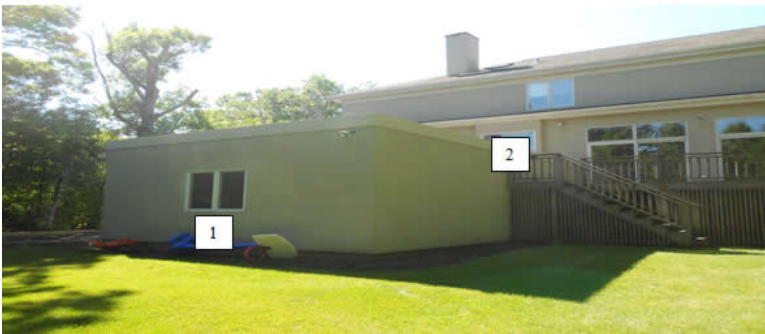
- 1) over 50% moisture
- 2) 17% moisture

The moisture readings behind the EIFS system appeared to be a high in several areas. I think if you caulk the miter and mullion joints it should lower the moisture readings into the acceptable range. The area over 50% should be removed and investigated further. 0-19% moisture is acceptable, 20-30% if recaulked/reflashed should dry out over time, over 31% should be

removed and investigated further. All soft substrate areas should be removed and replaced. (See attached photos)
