Illinois Inspection Service

Specializing in EIFS Inspections

Burr Ridge, IL

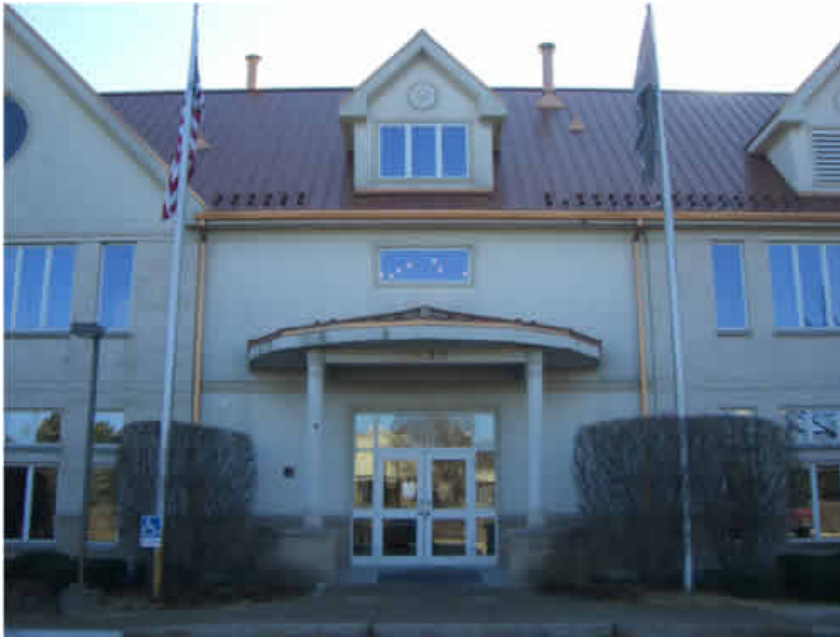
The moisture readings behind the EIFS system appeared to be normal. 0-19% moisture is acceptable, 19-30% if recaulked or kickout flashings are installed should dry out over time, and over 30% should be removed and investigated further. (see attached photos)

Moisture readings checked ok

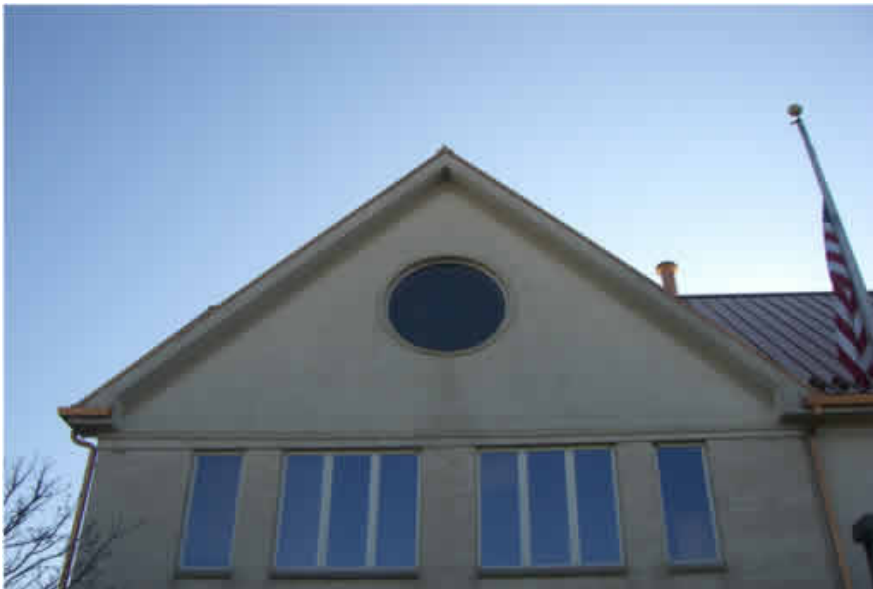
Moisture readings checked ok (typical)

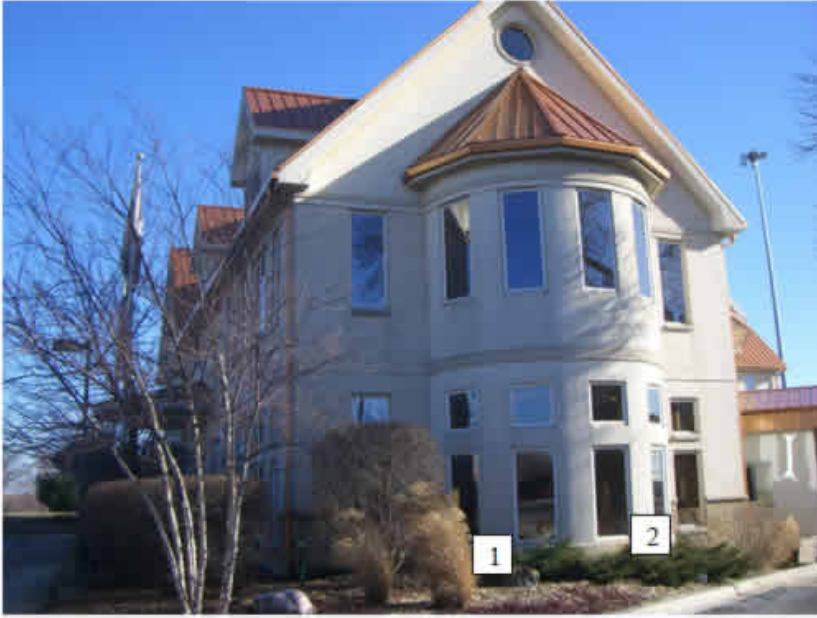
1. 10% moisture reading
2. 8% moisture reading

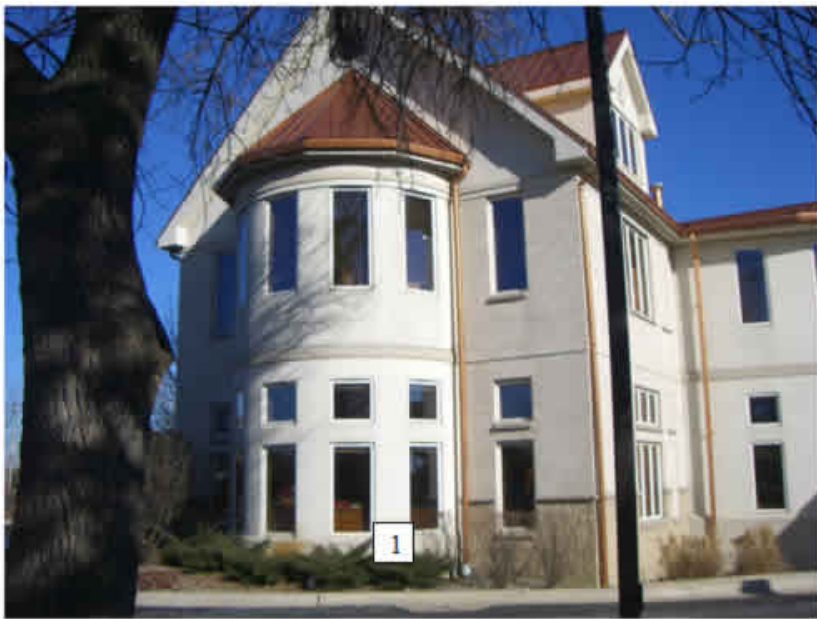
1. 8% moisture reading

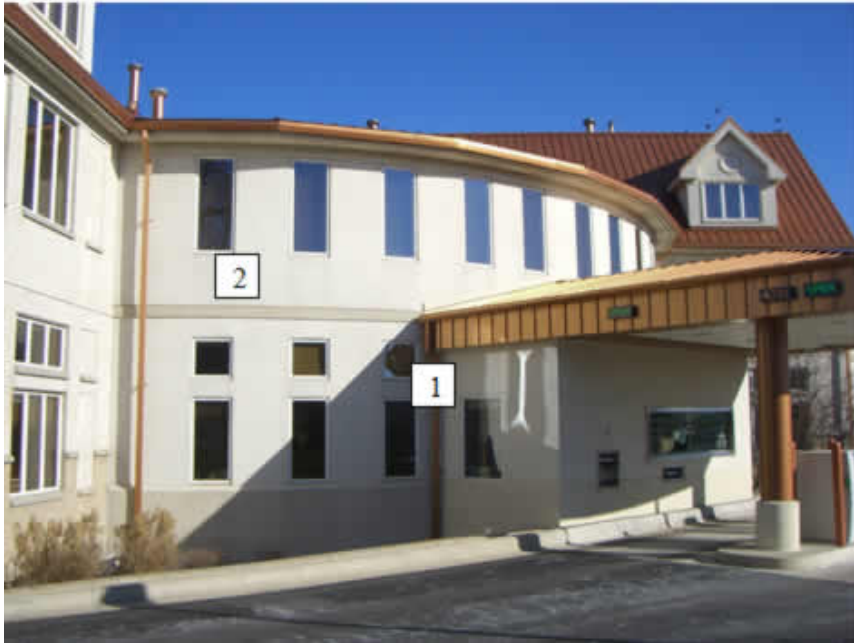
1. 12% moisture reading
2. 8% moisture reading

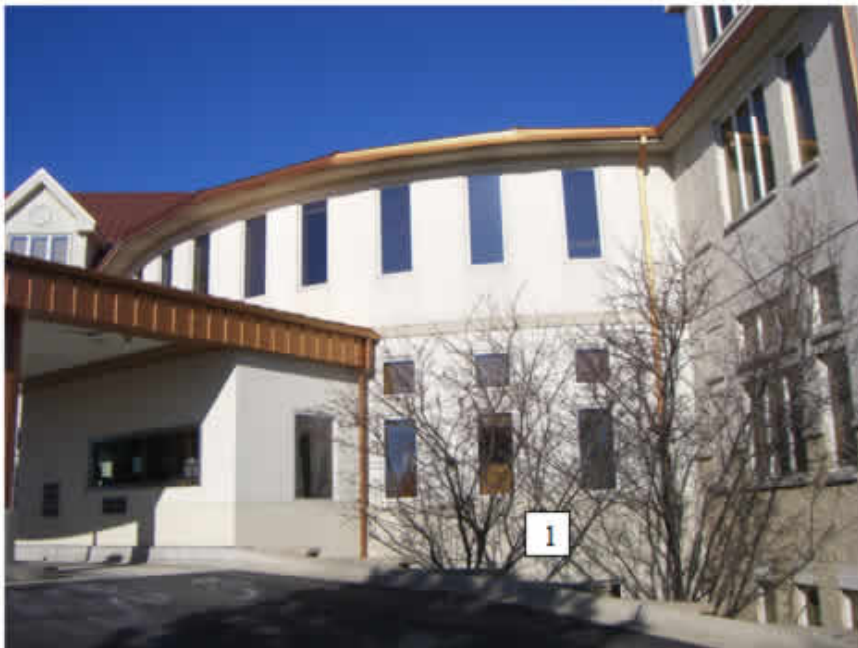
1. 10% moisture reading
