## Illinois Inspection Service

Specializing in EIFS Inspections

Long Grove, IL

Product: Dryvit

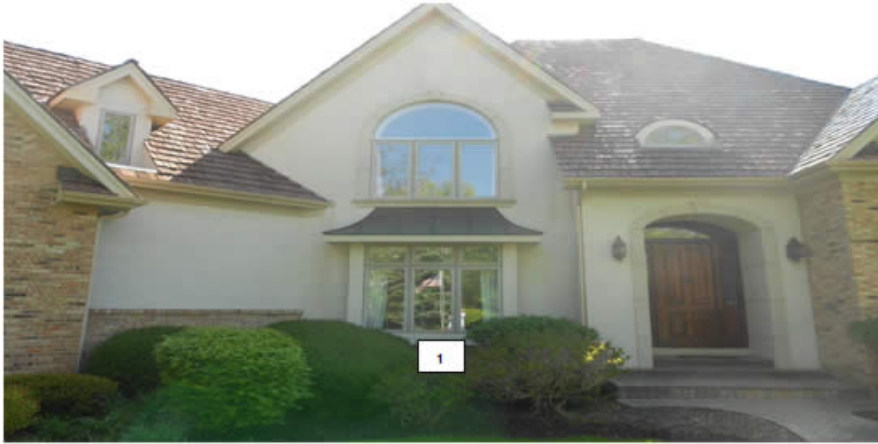
1) 12% moisture reading

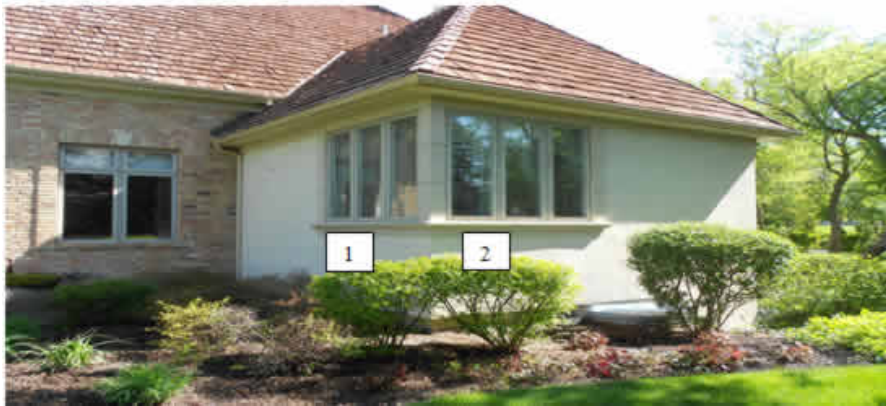
1) 15% moisture reading  
2) 22% moisture

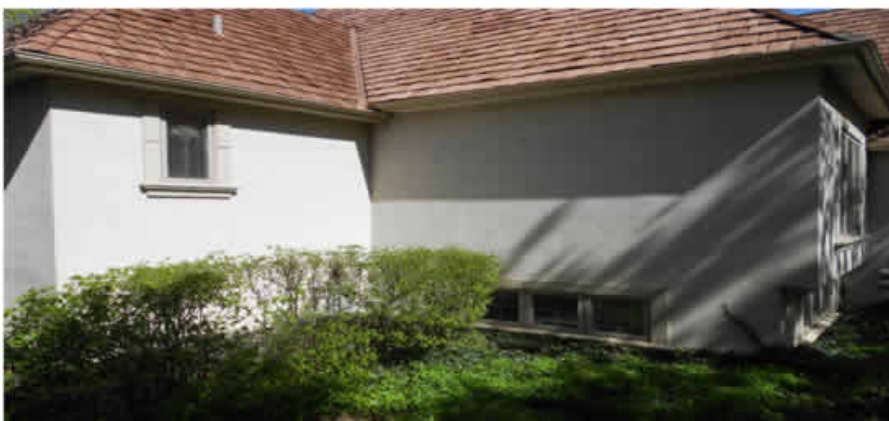
Moisture checked ok

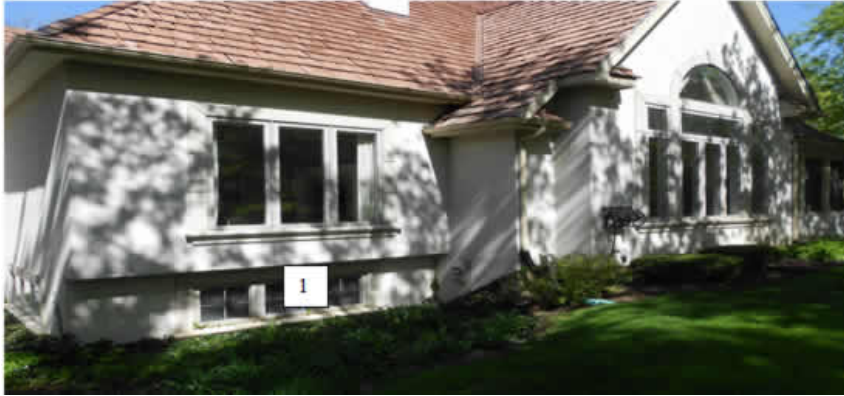
1) 18% moisture reading

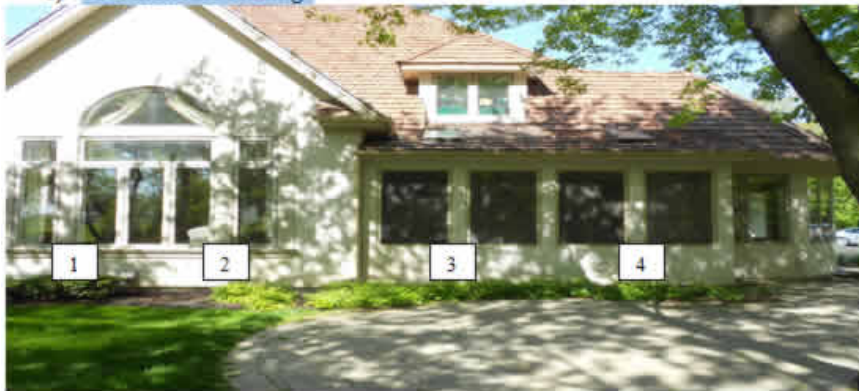
The moisture readings behind the EIFS system appeared to be a high in several areas. These areas should be removed and investigated further. 0-19% moisture is acceptable, 20-30% if recaulked/reflashed should dry out over time, over 31% should be removed and investigated further. All soft substrate areas should be removed and replaced. (See attached photos)

- 1) 50%+ moisture reading with soft substrate
- 2) 48% moisture with soft substrate
- 3) 12% moisture
- 4) 10% moisture

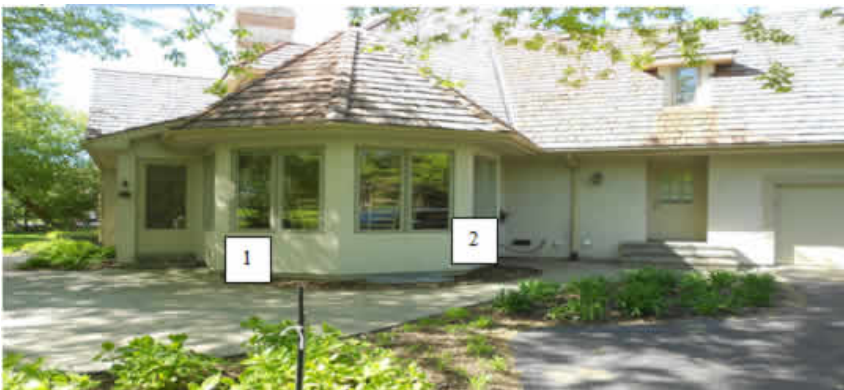
- 1) 9% moisture reading
- 2) 11% moisture
